Septodont Case Studies *Collection*

No. 05 - June 2013

BIODENTINE™

Biodentine™, a promising bioactive material for the preservation of pulp vitality in restorative dentistry

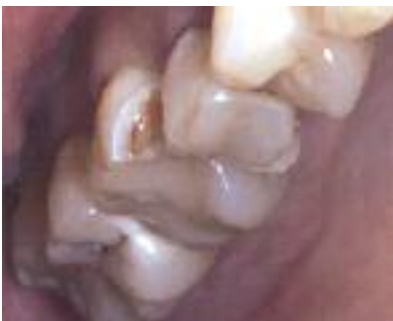
Fig. 12: Preoperative clinical picture showing fracture of tooth # 26
Preoperative radiograph showing deep caries in teeth # 26 and 27 in close proximity to the pulp

A 28 year-old female patient, with free medical history, came after fracture of her first upper left molar (# 26), which occurred during chewing (Fig. 12). Clinical and radiographical examination revealed deep caries at a very high proximity to the pulp in both upper molars (# 26 and # 27) (Fig. 13). Tooth # 26 had already a composite resin filling that was placed 2 years earlier. Clinical examination also showed that both teeth were positive on CO₂ snow sensitivity and negative on percussion. The patient did not mention any previous symptomatology derived from these teeth in her dental history. However, she mentioned that her two lower molars (# 36 and # 46) were endodontically treated due to deep caries that were symptom-free and therefore could not be diagnosed until they reached the pulp cavity. The patient was informed about the need of having the carious lesions treated and the possibility that an endodontic treatment would be required after caries removal.

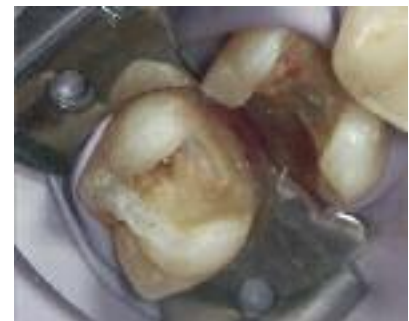
Fig. 14: After caries removal the pulp was exposed iatrogenically in tooth # 26, whereas a very thin pulp facing layer of dentin could be observed in the distal area of 26, as well as the proximal area of 27.

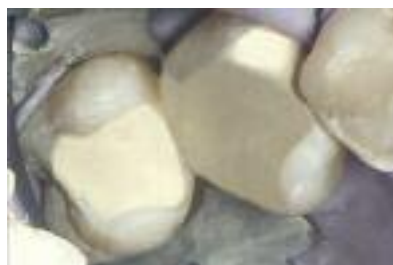
Fig. 16: Biodentine™ was placed as a bulk material to restore both cavities and left in place for 6 weeks. A rubber dam was used to avoid bacterial contamination after pulp exposure

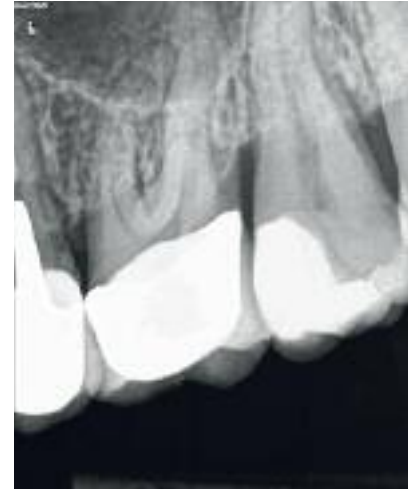
Fig. 20: Radiograph six months post treatment. No signs of periapical pathology could be observed

significant loss of dental hard tissues after caries removal. The tooth was prepared without removing Biodentine™ that remained and served as an abutment core build-up material (Fig 18). The final metal-ceramic crown was cemented with a conventional GIC (Fuji I, GC) (Fig. 19). At the follow-up visit after 6 months both teeth were free from any symptomatology and again tested positive for sensitivity and negative for percussion. Radiographical examination showed no signs of periapical pathology (Fig. 20).

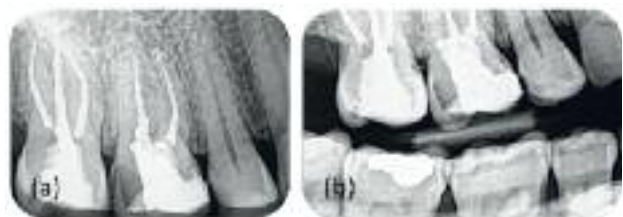
Fig. 1: (a) Periapical radiograph of tooth #3 revealed a previous endodontic treatment and a possible missed disto-buccal root canal. (b) Bite-wing radiograph provided more precise information about the condition of the pulp chamber.

tooth # 3 revealed composite restoration, previous endodontic treatment with no signs of periapical radiolucency, and a possible missed root canal in the distal root (*Fig. 1a, b*). Based on the clinical and radiographic findings, symptomatic apical periodontitis was diagnosed and endodontic retreatment scheduled.

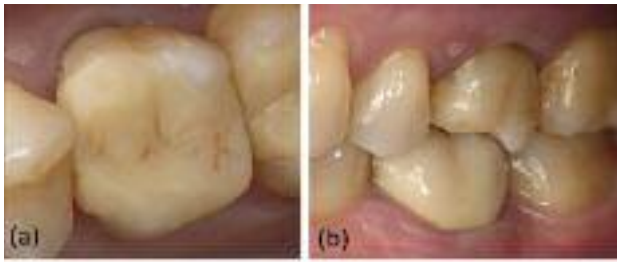
Fig. 6: (a) Tooth #14 with composite resin overlay. (b) Lateral view of tooth #14.

contained no abnormal data. On examination the tooth showed a composite resin overlay (**Fig. 6a,b**). Clinically, the tooth was negative to palpation and percussion; radiographic examination revealed incomplete root canal fillings and signs of periapical radiolucency (**Fig. 7a-c**). Having diagnosed an asymptomatic apical periodontitis we suggested non-surgical treatment. Informed consent was obtained from the patient, and a small volume CBCT was taken using ProMax 3Ds (Planmeca OY, Helsinki, Finland) to reveal the exact location of the untreated root canals. The tooth involved was pinpointed, and the morphology was obtained in coronal, axial and sagittal sections of 0.5mm thickness. The axial and coronal images showed the presence of the mesio-buccal and disto-buccal root canal, as well as a furcal perforation (**Fig. 8a,b**).

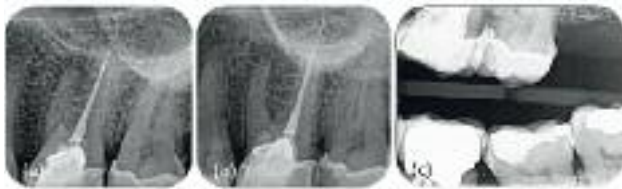
Fig. 7: (a,b) Pre-operative periapical radiographs (parallax technique) with different horizontal angulations. (c) Bite-wing radiograph.

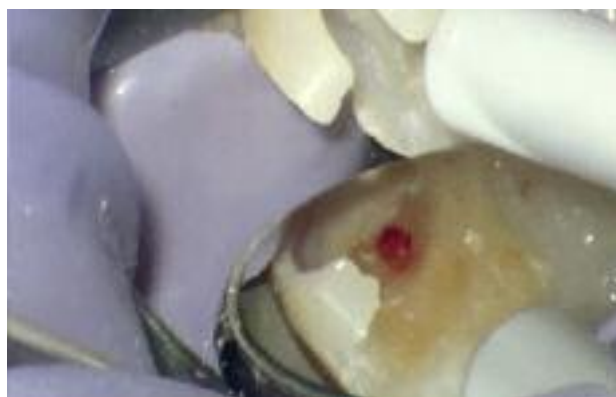
Fig. 2

Local anaesthetic was administered, the tooth isolated with rubber dam and the caries excavated which revealed an exposure of the distal pulp horn (*Fig. 2*) with normal vital pulp tissue. The cavity was irrigated with 3% sodium hypochlorite for 30 seconds and then rinsed thoroughly with copious amounts of sterile water. The cavity was then dried taking care to not desiccate the pulp.

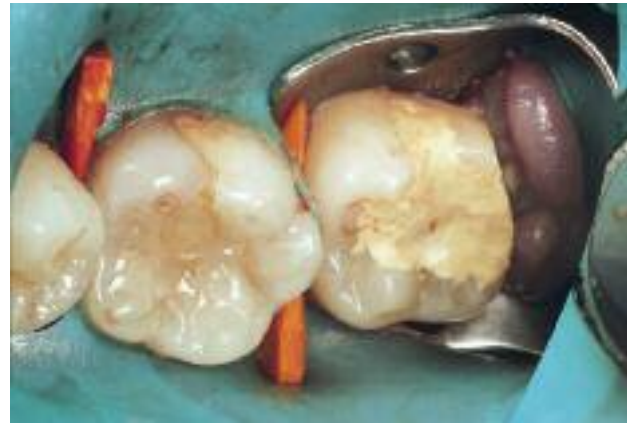
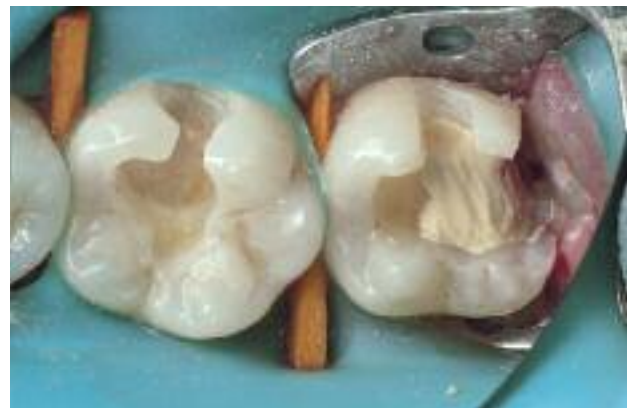
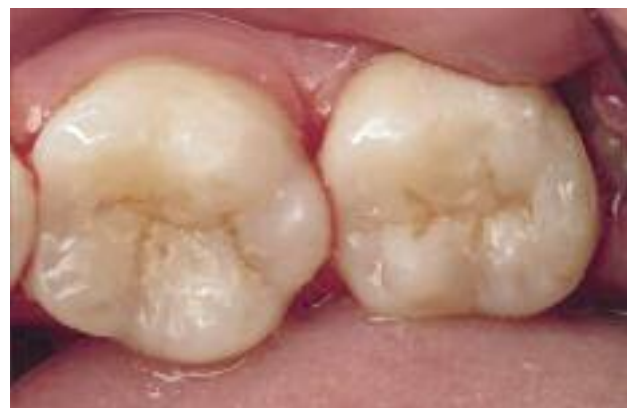
Fig. 7

At a subsequent appointment some two weeks later my colleague Jose Antonio Victoria Ortega carried out a conventional cavity preparation leaving a layer of Biodentine™ over the exposed pulp and provided bonded composite restorations. (Fig. 7, 8, 9)

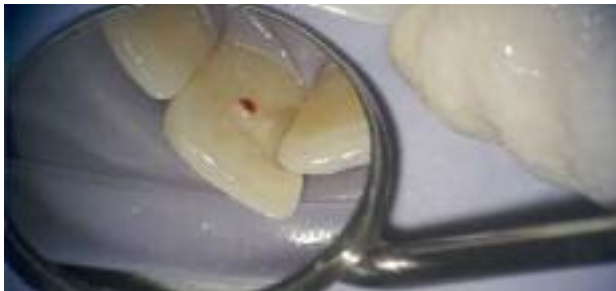
Fig. 12

Local anaesthetic was administered and the tooth isolated with rubber dam. The composite restoration was removed which revealed the extent of the lesion.(Fig. 12) Pulpotomy was performed, the cavity irrigated with 3% sodium hypochlorite, rinsed thoroughly with sterile water and the pulp gently dried with sterile paper points.

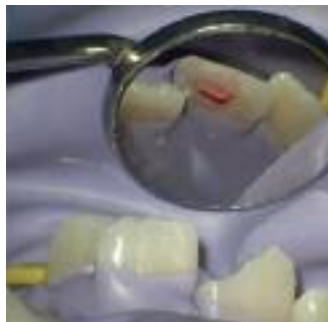
Fig. 16

Local anaesthetic was administered and the tooth isolated with rubber dam. Pulpotomy was performed, (Fig. 16) Biodentine™ placed passively on the pulp stump with a Thymozin instrument (Fig. 17) and allowed to set. (Fig. 18) GIC was placed over the set Biodentine™. A cosmetic repair will be provided at a later date.
