Mar 3, 2009 | COSMETIC DENTISTRY

The renaissance of a classic: Tetric-N Ceram—a perfect combination of experience and innovation

by Eduardo Mahn, Liechtenstein

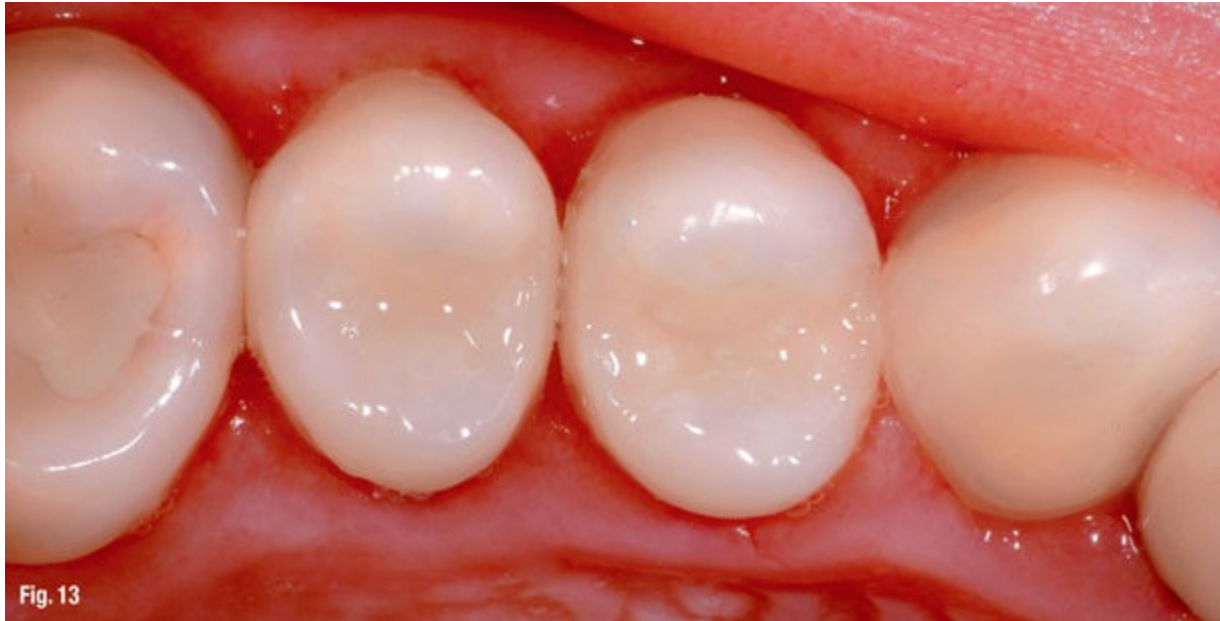
Fig. 13: The restorations after 4 weeks.

Once we placed the matrix (OptraMatrix), we built up the proximal cavity walls, thus creating tight proximal contacts. Due to the 10 µm thick OptraMatrix, it is easy to achieve tight contact points (Figs. 9, 10). These functional contacts are the key to prevent periodontal damage, food impact and the resulting secondary caries. After finishing tooth 24, the same procedure was applied on tooth 25 (Fig. 11). Predictable, high-quality results, with regard to proximal contacts and occlusal surfaces prior to polishing, are achieved due to the incremental technique and the easy handling properties of the material (Fig. 12). Finally, the restorations were finished and polished to achieve an exceptionally aesthetic appearance. Due to the excellent final gloss and the chameleon effect of the composite, the restorations are almost invisible (Fig. 13).
